PUBLIC RIGHTS OF WAY SURVEY

October 2025

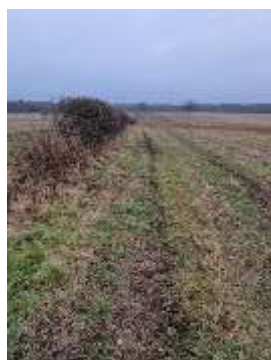
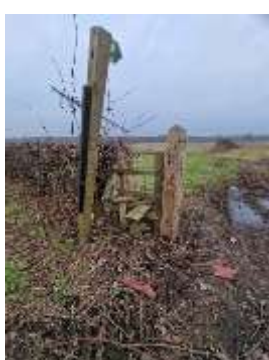
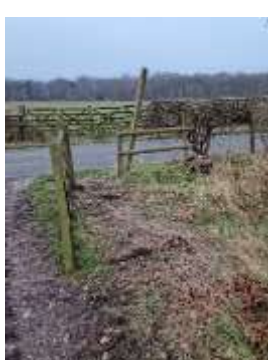
FP1 MANCHESTER ROAD TO MEREHEATH LANE

Survey Category	Survey Finding
Date of Survey	19 th January 2025
Description of Path	Footpath following a hawthorn hedge between farmed fields
Surface Description	Rough grass
Width between boundaries	Approximately 200 m
Available/Usable width	Several metres wide
Boundaries	Hedge on one side
Ease of Access	Access to the footpath is easier by walking through the un-gated field entrance rather than using the stile.
Signs	Two signs, one at each end of the path. Both slightly askew but are readable and can be easily seen from the road
Path Furniture	Stile at Manchester Road end is in fair condition
Lighting	None
Obstructions	None
General Cleanliness	Generally clean
Litter/ Fly Tipping	Discarded traffic cone on the path. Some litter near stile.
Trade Waste	None
Dog Fouling	None
Graffiti/ Vandalism	None
General Comments	
Improvements	<ul style="list-style-type: none"> • Minor repairs to signposts to make vertical • Clearing of litter

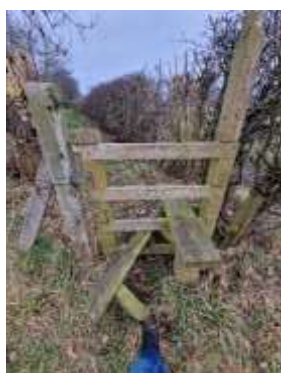
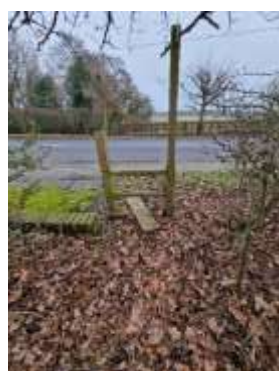
FP2 MANCHESTER ROAD TO GREEN LANE

Survey Category	Survey Finding
Date of Survey	19 th January 2025
Description of Path	Narrow path bordering the Land Rover sales garage then across a field.
Surface Description	Field Path – path occasionally ploughed over
Width between boundaries	1m for path then width of field.
Available/Usable width	As above
Boundaries	Hedge on one side and Land Rover fence on the other for the path. No boundaries once on field.
Ease of Access	Not wheelchair/ pushchair accessible.
Signs	Two signs, one at each end of the path. Both in good condition.
Path Furniture	Two stiles, one at Manchester Road end and one midway. Metal Swing Gate at Green Lane. Midway Stile bottom step is dislodged, and nails are exposed. Other stile and gate are in good condition.
Lighting	None
Obstructions	Some branches from hedge
General Cleanliness	Generally clean
Litter/ Fly Tipping	Some litter.
Trade Waste	Old tyres on the border with the Land Rover garage

Dog Fouling	None
Graffiti/ Vandalism	None
General Comments	
Improvements	<ul style="list-style-type: none"> • Repair midway stile • Remove litter and old tyres

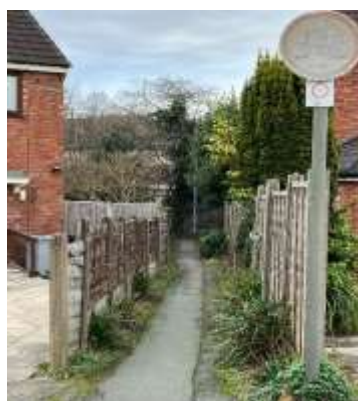
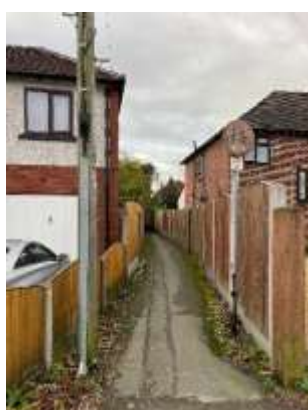
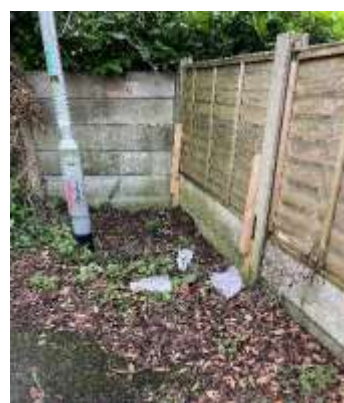
FP3 WESTFIELD DRIVE TO NORTHWICH ROAD

Survey Category	Survey Finding
Date of Survey	17 th December 2024
Description of Path	Alleyway between houses
Surface Description	Asphalt of varying condition
Width between boundaries	1.2 m – 1.7 m
Available/Usable width	As above
Boundaries	Fencing from houses, combination of concrete and timber, some covered in vegetation. Most in good condition, some repairs done by homeowners.
Ease of Access	Good
Signs	No cycling and no dog fouling signs at each end of the path. All signs are either very faded or difficult to read due to grime. The post at the Northwiche Road entrance is significantly corroded.
Path Furniture	None
Lighting	Galvanised steel column with LED luminaire, good condition but partially obscured by vegetation.
Obstructions	Some vegetation on edge of path, overhanging branches in the centre section.
General Cleanliness	Good
Litter/ Fly Tipping	Some, mostly in the centre section near the lamppost

Trade Waste	None
Dog Fouling	Bags of dog waste in centre section
Graffiti/ Vandalism	Graffiti on lighting column and adjacent fence
General Comments	Generally good – ‘better than most’
Improvements	<ul style="list-style-type: none"> • Repair sign post and replace/clean signs. • Cut back some vegetation. • Tidy up litter. • Remove graffiti.

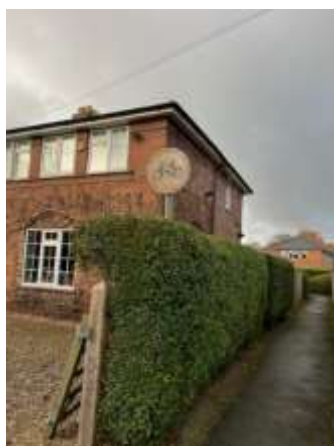
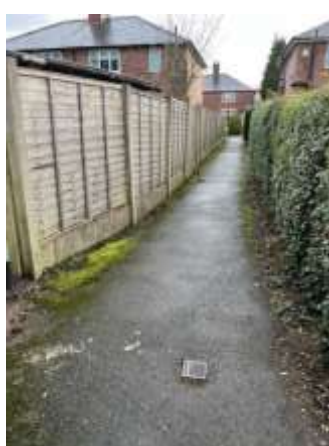
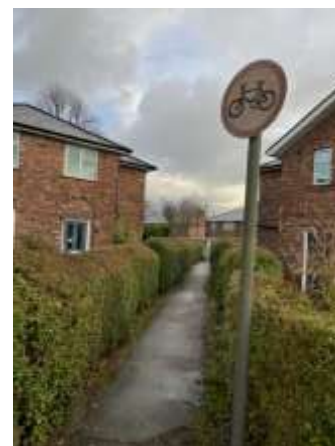
FP4 RACEFIELD ROAD TO HEATHFIELD SQUARE

Survey Category	Survey Finding
Date of Survey	14 th December 2024
Description of Path	Alleyway between houses
Surface Description	Tarmac throughout, some areas around surface covers eroded
Width between boundaries	2 m
Available/Usable width	The whole width is useable
Boundaries	Combination of fences and hedges in good condition
Ease of Access	Flat path in good condition. Dropped curbs in appropriate places to help access.
Signs	'No cycling' signs at either end, worn
Path Furniture	None
Lighting	Streetlight in good condition at midpoint
Obstructions	None
General Cleanliness	Good condition
Litter/ Fly Tipping	None
Trade Waste	None
Dog Fouling	None
Graffiti/ Vandalism	None
General Comments	
Improvements	<ul style="list-style-type: none"> • Replace sign at Racefield Road end

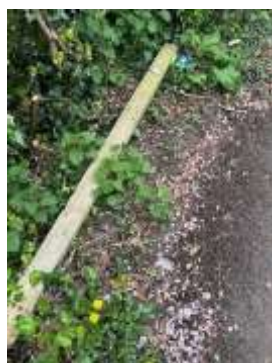
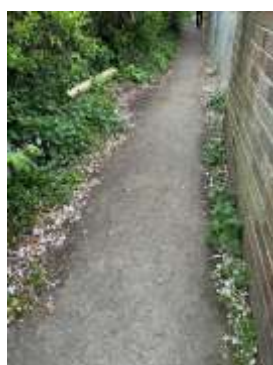
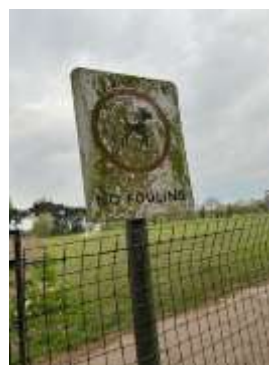
FP5 WESTFIELD DRIVE TO TABLEY SUPERIOR FP12

Survey Category	Survey Finding
Date of Survey	15 th April 2025
Description of Path	Narrow footpath alongside Knutsford Academy opening into a field
Surface Description	Concrete footpath with some erosion then earth track
Width between boundaries	1 m then open field
Available/Usable width	0.5 – 1 m then dependant on crops
Boundaries	Wire fence along school side and domestic fences then open field
Ease of Access	Flat track but uneven
Signs	Footpath sign at the school end, lying in the vegetation and no longer visible. Two 'no dog fouling' notices on each end of the school path, both need cleaning. Footpath sign at end of school path in good condition.
Path Furniture	Bin at the entrance of the path by the school in good condition.
Lighting	Street lights on road
Obstructions	Lots of nettles on the school path
General Cleanliness	Good
Litter/ Fly Tipping	Little
Trade Waste	None
Dog Fouling	Some on the school footpath

Graffiti/ Vandalism	None
General Comments	Footpath at the school end is narrow but opens out to open fields and trees
Improvements	<ul style="list-style-type: none"> • Remove nettles • 'No dog fouling' signs need cleaning • Footpath sign re-fitted

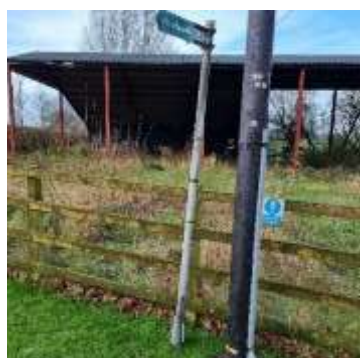
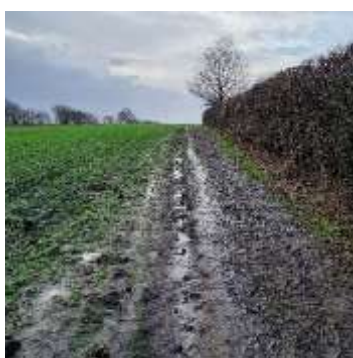
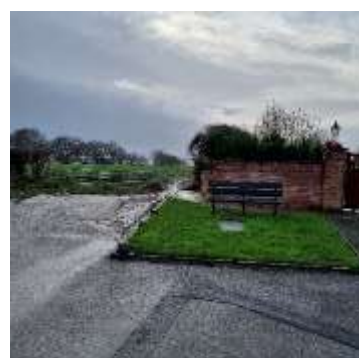
FP6 BLACKHILL FARM TO BEXTON PARISH BOUNDARY

Survey Category	Survey Finding
Date of Survey	21 st December 2024
Description of Path	Farmer's access path around edge of field
Surface Description	Rutted mud track
Width between boundaries	3 – 4 m as it is possible to also walk on field
Available/Usable width	Varies depending on if crop is planted
Boundaries	Hedge on one side, open field on the other.
Ease of Access	Flat but muddy and rutted
Signs	Footpath sign at Blackhill Farm end in good condition
Path Furniture	Bench at Blackhill Farm end in good condition
Lighting	Lamppost near to Blackhill Farm end, this is leaning
Obstructions	None
General Cleanliness	
Litter/ Fly Tipping	Used dog poo bags
Trade Waste	None
Dog Fouling	Lots
Graffiti/ Vandalism	None
General Comments	Good path but weather dependant
Improvements	<ul style="list-style-type: none"> • Install bin at Blackhill Lane

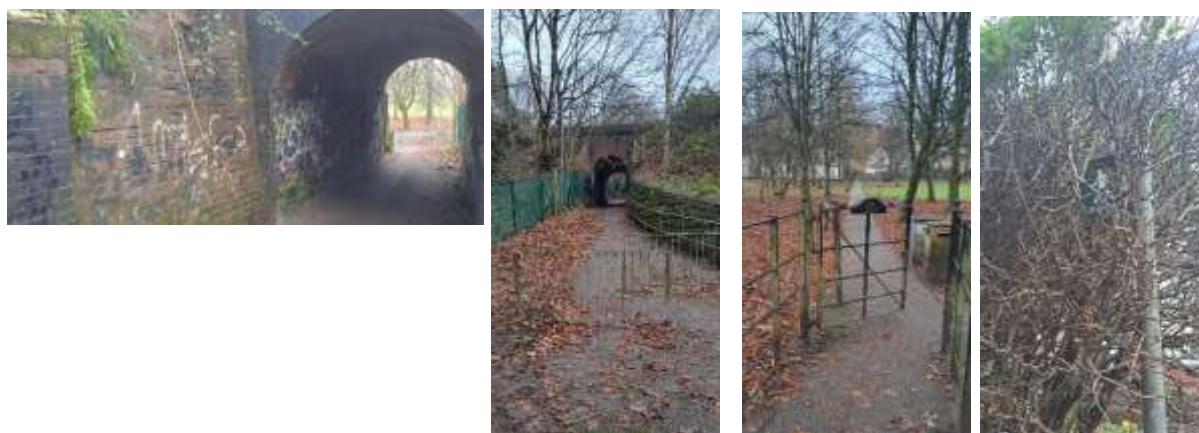
FP 8 MOBBERELY ROAD TO SWINTON SQUARE VIA BARNCROFT AND MOOR

Survey Category	Survey Finding
Date of Survey	13 th December 2024
Description of Path	Tarmac path across Coronation Square and past St Cross Church
Surface Description	Tarmac in good condition
Width between boundaries	1.5 m
Available/Usable width	As above
Boundaries	Hedges and fences in good condition
Ease of Access	Even path, handrails present where steep
Signs	Footpath sign at each end, sign at Mobberley road end concealed by hedge. Plants of the moor sign in good condition
Path Furniture	Plenty of bins and benches in good condition. Handrails in steep places in good condition. Railings to slow bikes etc near railway bridge. Gate at entrance to Coronation Square, some algae on the gate and railings
Lighting	Street lighting
Obstructions	None
General Cleanliness	Good
Litter/ Fly Tipping	Minimal litter
Trade Waste	None
Dog Fouling	None
Graffiti/ Vandalism	Graffiti on railway bridge and fence.
General Comments	Path in good condition, no obstructions, clean and tidy

Improvements	<ul style="list-style-type: none"> Cut back hedges around sign at Mobberley Road end.

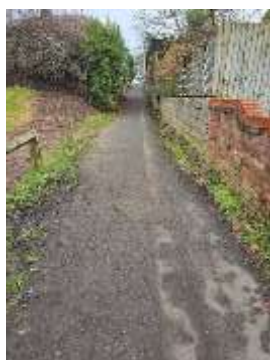
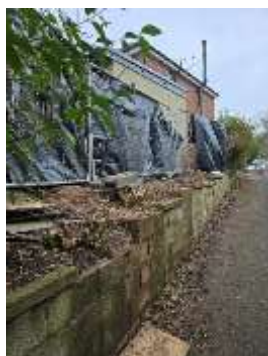
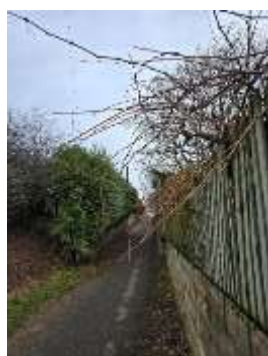
FP 9 MOBBERLEY ROAD TO WOODLANDS DRIVE

Survey Category	Survey Finding
Date of Survey	19 th January 2025
Description of Path	Alleyway between houses
Surface Description	Tarmac
Width between boundaries	2 m
Available/Usable width	As above
Boundaries	Hedges and fences from houses
Ease of Access	Slight gradient but even path
Signs	None
Path Furniture	None
Lighting	None
Obstructions	Overhanging bushes and branches
General Cleanliness	Leaf litter
Litter/ Fly Tipping	Some
Trade Waste	None
Dog Fouling	None
Graffiti/ Vandalism	None
General Comments	Footpath is used by a lot of people
Improvements	<ul style="list-style-type: none"> • Clear leaf litter and vegetation

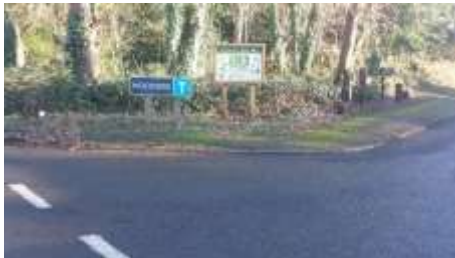
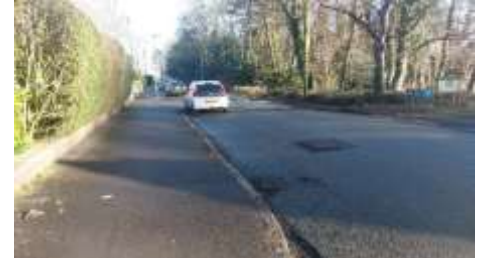
FP 13 THORNEYHOLME DRIVE TO MANOR PARK NORTH

Survey Category	Survey Finding
Date of Survey	14 th December 2024
Description of Path	Pavement adjacent to road
Surface Description	Tarmac in good condition
Width between boundaries	2.5 m
Available/Usable width	As above
Boundaries	Domestic residences, driveways, fences, hedges etc
Ease of Access	Flat with several dropped curbs
Signs	General road signs, none footpath specific
Path Furniture	Bin near the school
Lighting	Lampposts at intervals
Obstructions	None
General Cleanliness	Good
Litter/ Fly Tipping	None
Trade Waste	None
Dog Fouling	None
Graffiti/ Vandalism	None
General Comments	Residential road
Improvements	None.

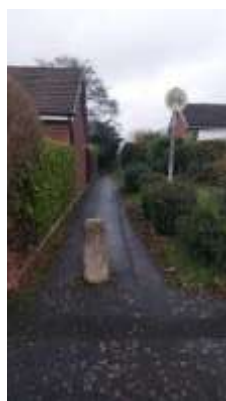
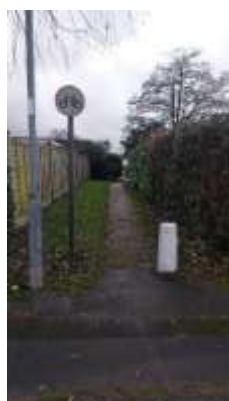
FP 13 KENILWORTH AVENUE TO BROOKDALE AVENUE

Survey Category	Survey Finding
Date of Survey	14 th December 2024
Description of Path	Path between houses
Surface Description	Tarmac, a few minor cracks
Width between boundaries	1.6 – 1.8 m
Available/Usable width	As above, restricted at ends by bollards
Boundaries	Domestic brick walls, fences, and bushes
Ease of Access	Flat but dropped curbs are not close
Signs	No cycling sign at either end, both are faded but readable
Path Furniture	Bollard at either end in good condition
Lighting	Street lighting at each end of the path, none on the path
Obstructions	None
General Cleanliness	Clean
Litter/ Fly Tipping	None
Trade Waste	None
Dog Fouling	None
Graffiti/ Vandalism	None
General Comments	Fine
Improvements	<ul style="list-style-type: none"> Consider removing bollards to make path accessible to all

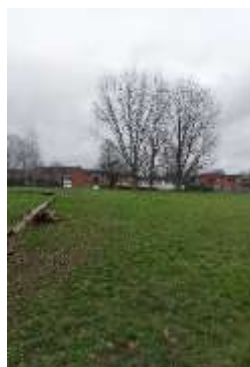
FP 13 BOOTHFIELDS TO ST HELENA'S CHURCH

Survey Category	Survey Finding
Date of Survey	14 th December 2024
Description of Path	Historic alignment of path is obstructed by houses on Boothfields, path unclear across public open space (grass) to Longridge
Surface Description	Grass field then tarmac pavement
Width between boundaries	Width of field then 1.5 m pavement
Available/Usable width	As above
Boundaries	Domestic fences, bushes etc
Ease of Access	Muddy path across the field
Signs	None
Path Furniture	None
Lighting	Street lighting on Longridge
Obstructions	None
General Cleanliness	Muddy but generally clean
Litter/ Fly Tipping	None
Trade Waste	None
Dog Fouling	None
Graffiti/ Vandalism	None
General Comments	Vague route across recreation field to roadways
Improvements	<ul style="list-style-type: none"> Definitive map location and on the ground, location is confused – check with CEC for official alignment of the path

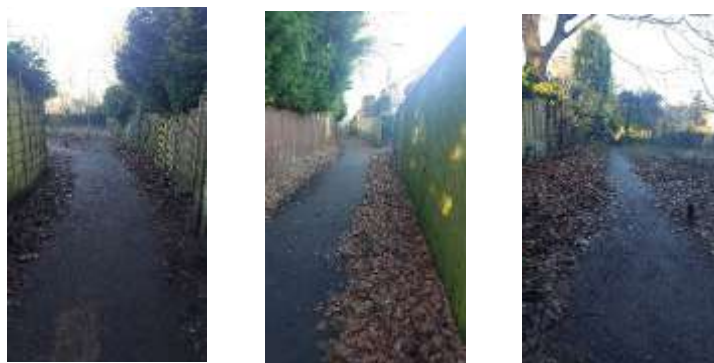
FP14 SPARROW LANE TO HIGHER DOWNS

Survey Category	Survey Finding
Date of Survey	15 th January 2025
Description of Path	Alleyway between houses
Surface Description	Tarmac in good condition
Width between boundaries	1.3 – 2 m
Available/Usable width	1.3 – 1.9 m
Boundaries	Domestic fences
Ease of Access	Easily accessible, with slight gradients
Signs	None
Path Furniture	None
Lighting	Several lampposts in good condition
Obstructions	Some overhanging branches
General Cleanliness	Lots of dead leaves at time of survey
Litter/ Fly Tipping	None
Trade Waste	None
Dog Fouling	None
Graffiti/ Vandalism	None
General Comments	Fine, accessible
Improvements	Clear vegetation

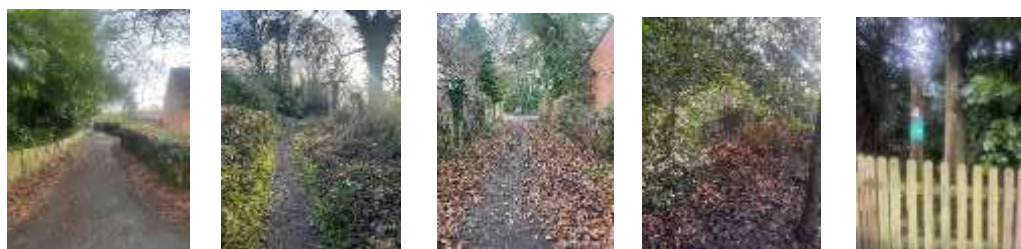
FP19 LEYCESTER ROAD TO GOUGHS LANE

Survey Category	Survey Finding
Date of Survey	14 th December 2024
Description of Path	340m pathway between houses and a field. First 100 m a single lane track to Humbug Cottage. The next 150 m is a footpath between the field and gardens, with pedestrian access gates to several properties. The final 90 m is a single lane track to Goughs Lane.
Surface Description	The first 100 m is hardstanding. Several potholes with some being filled, the track also prone to flooding. The next 150 m is a muddy dirt path then the final 90 m is a dirt track in generally good condition.
Width between boundaries	8 – 3 m depending on point in track
Available/Usable width	1 – 3 m depending on point in track
Boundaries	Domestic fences and walls etc in good condition. Barbed wire fence next to field, broken in some places.
Ease of Access	Generally flat track, wide enough for access but nature of the path means not always accessible

Signs	Footpath sign at Leicester Road end in good condition. Signpost at Goughs Lane end is missing, post is on the floor and is rotting.
Path Furniture	None
Lighting	No lighting except for those from domestic properties.
Obstructions	A few overhanging branches and lots of surface vegetation in middle section.
General Cleanliness	Very good, minimal litter
Litter/ Fly Tipping	None
Trade Waste	None
Dog Fouling	None
Graffiti/ Vandalism	None
General Comments	As a local resident, I have on occasion trimmed this back [vegetation] to maintain good accessibility.
Improvements	Replace sign at Goughs Lane. Trim back some vegetation.

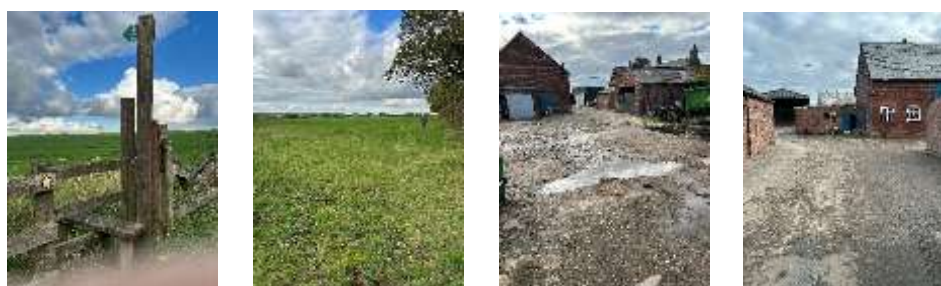
FP30 NORTHWICH ROAD TO TABLEY HILL LANE

Survey Category	Survey Finding
Date of Survey	22 nd October 2025
Description of Path	Across fields
Surface Description	Grass across fields, concrete through farmyard then a drive
Width between boundaries	Wide across open fields, narrowing at the drive to approx. 4.5m
Available/Usable width	No restrictions- wide space
Boundaries	Hedges, fencing and barbed wire
Ease of Access	Flat, no steps but very muddy – not accessible to all
Signs	Footpath sign at Northwich Road and Tabley Hill Lane end both in good condition but path is unclear
Path Furniture	One stile at Northwich Road end and one at the end of the field, both in good condition
Lighting	None
Obstructions	None
General Cleanliness	Very clean path
Litter/ Fly Tipping	None
Trade Waste	None
Dog Fouling	None
Graffiti/ Vandalism	None
General Comments	Extremely muddy path. Unclear where the footpath goes. Footpath sign at Tabley Hill Road sign is obscured by trees. No signage from the Tabley Hill Road end through the farm

Improvements	<ul style="list-style-type: none"> • Signage through the farm to indicate footpath • More defined route marked out from Tabley Hill Road end
