Knutsford Town Centre Feasibility Studies

Phase 1 Ground Conditions Desk Study Report

Doc ref: 33014-HYD-XX-XX-RP-GE-0001

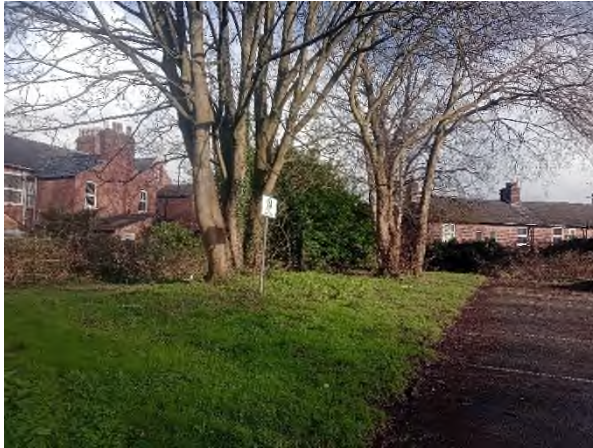
Figure 2.3: Mature trees on northern boundary.

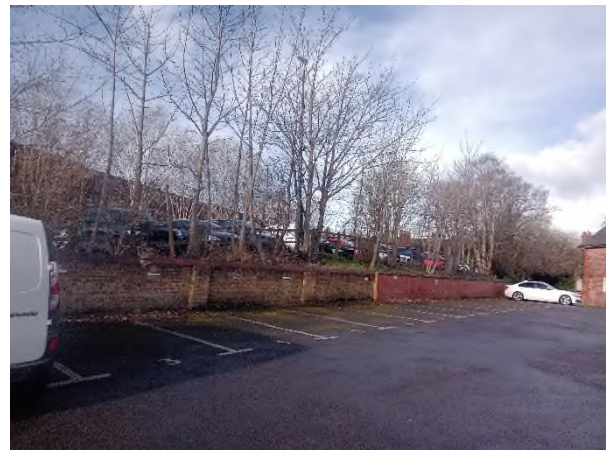
Figure 2.6: Retaining wall on eastern site boundary. Photograph taken from the Caledonian Car Park.

- » Existing retaining walls integrity and impact on foundations, floor slabs, roads and infrastructure and construction plant.
- » Potential for obstructions and the risk of instability of excavations with the impact on construction staff, vehicles and plant operators.

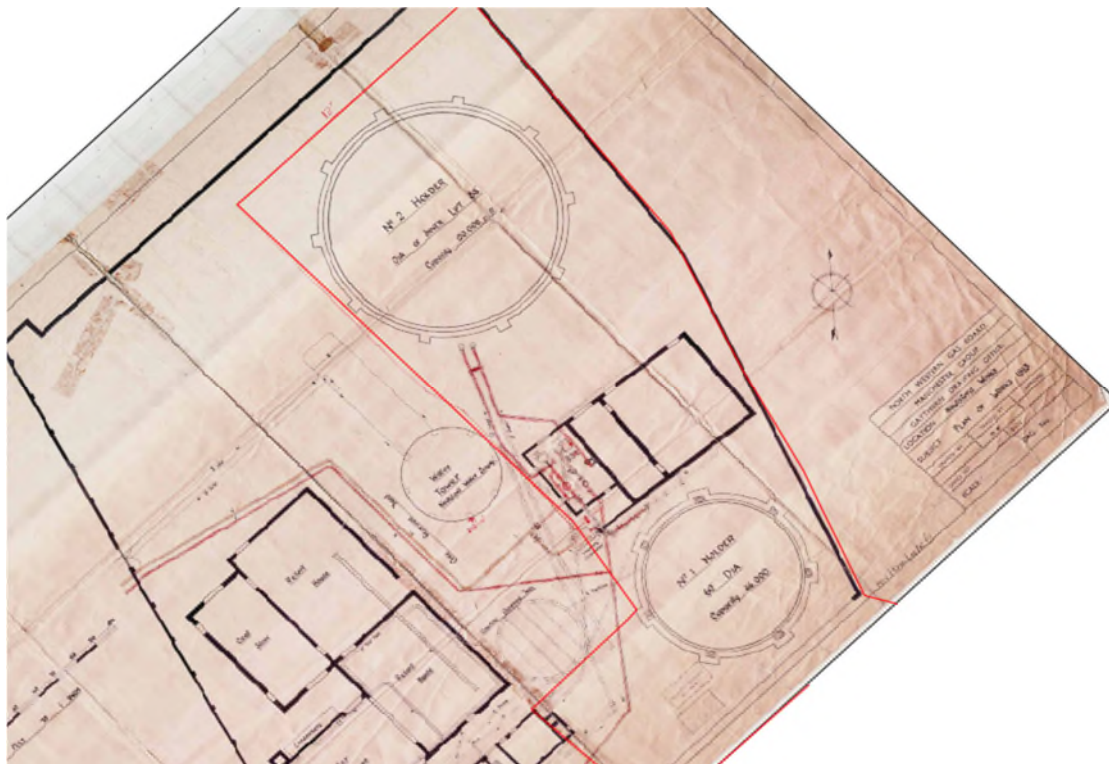
Figure 2.7: 1913 National Grid plan

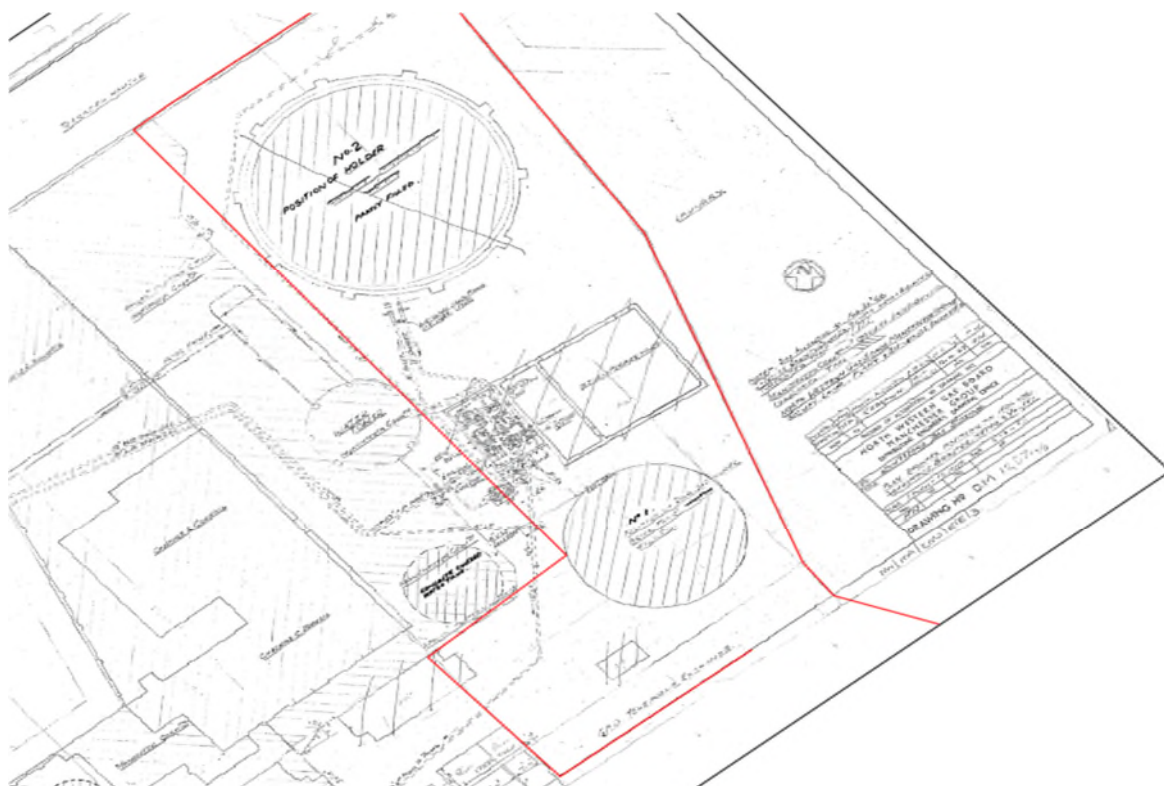
Figure 2.8: 1957 National Grid plan (Approximate Red Line Boundary Shown)

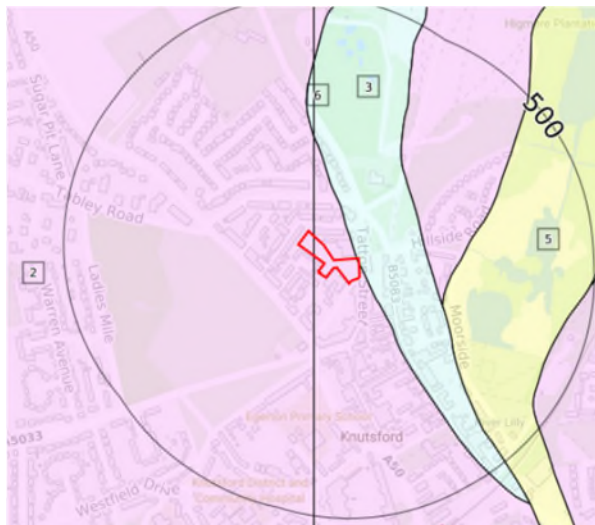
Figure 2.9: Superficial deposits.

Ref. for Figures	Location	Stratigraphic Name	Description
Superficial Deposits (Figure 2.9)			
1	On site	Glaciofluvial Deposits	Sand and gravel
3	North eastern boundary	Glacial Till	Clay with sands and gravel.
5	180m east	Alluvium	Clay, silt, sand and gravel.
Solid Geology (Figure 2.10)			
1	On site.	Northwich Halite Member	Halite with partings of mudstone.

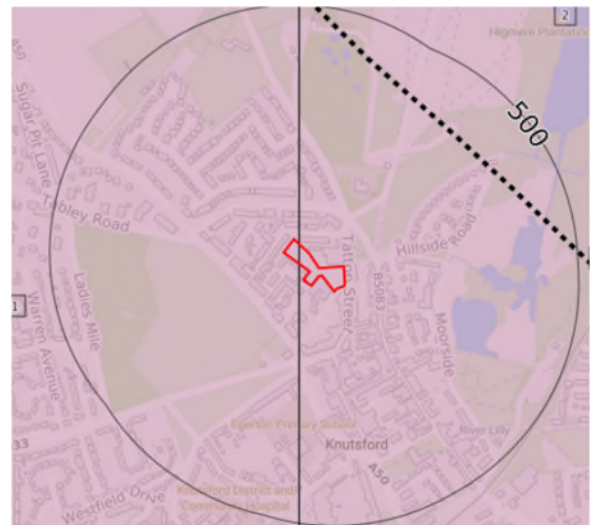
Figure 2.10: Solid geology.

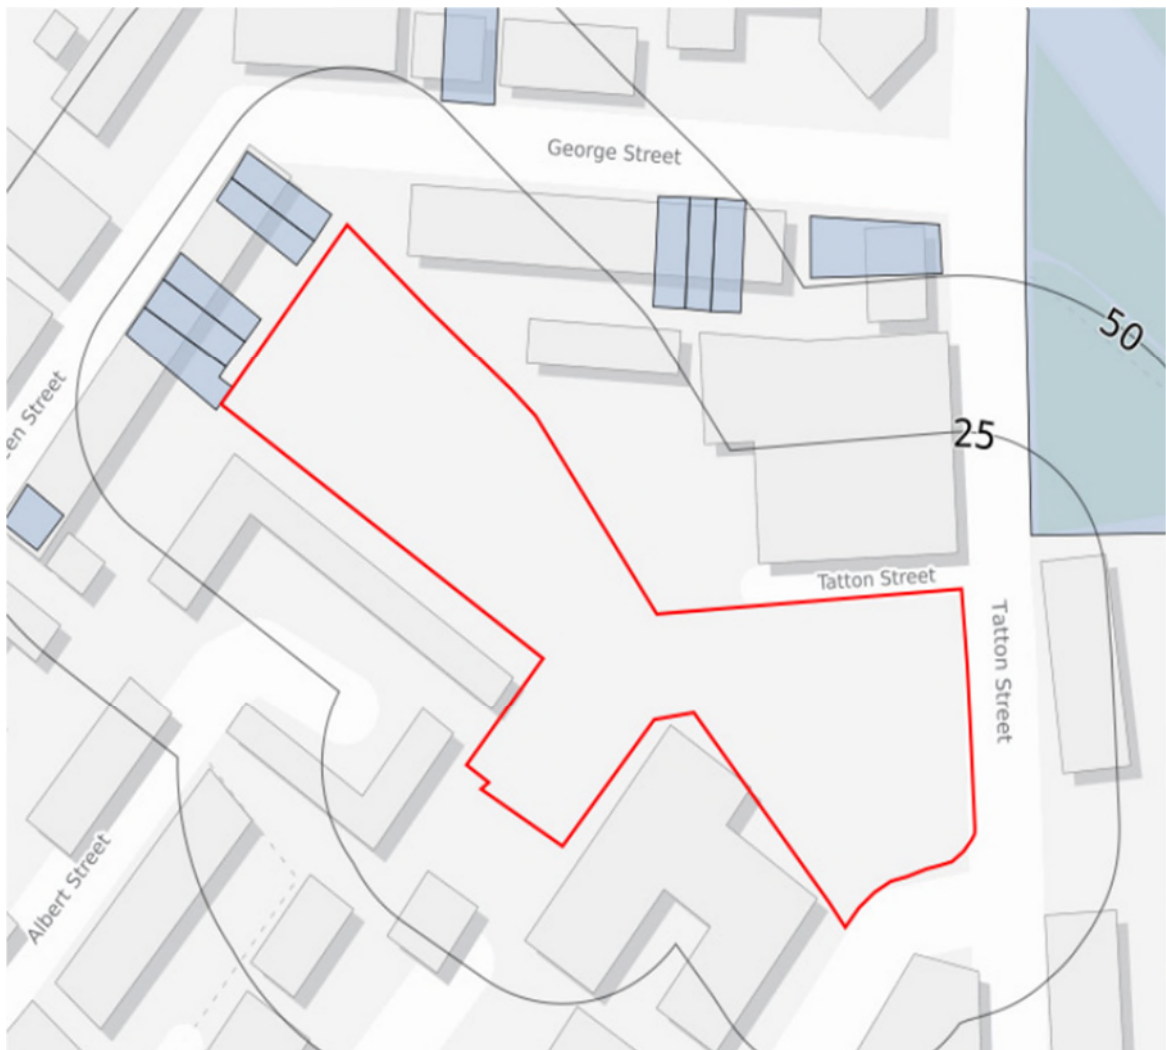
Figure 2.12: Prescribed Notice of Damage

- » The site is located within the compensation district as defined by the 1952 Act.
- » The site is located within a consultation area as prescribed by the Cheshire Brine Subsidence Compensation Board under the provisions of section 38(1) of the 1952 Act.
- » There have been no prescribed notices of damage filed in respect to the site since 8th January 1959.
 - » There are 5 buildings to the north west of the site within 20m which have prescribed notices of damage as shown in Figure 2.12.
 - » The site was of industrial use with most structures demolished by 1959 when Prescribed Damages of Notice were filed, there is unlikely to be prescribed notices of damage specific to site.
